Perils of Improper Clothes Dryer Venting

Chris J. Schoonover, P.E., LEED AP, CPMP

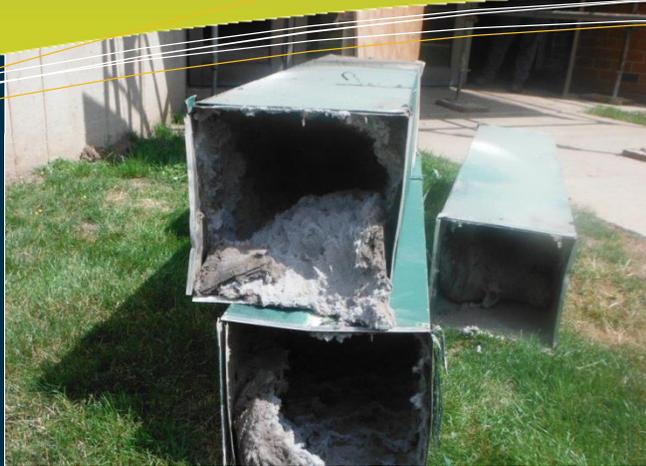
The above photo illustrates the result of an incorrectly vented dryer that we recently upgraded for a client. This is a case where dryers were installed without an engineered design. At best this system was not venting well, increasing energy costs since dryers were not performing optimally, and at worst this system had turned into a serious fire hazard. We corrected the system, with properly sized ductwork and a forced draft fan system.
